Measured Strain in Nb₃Sn Coils During Excitation and Quench

Abstract— The strain in a high field Nb₃Sn coil was measured during magnet assembly, cool-down, excitation and spot heater quenches. Strain was measured with a full bridge strain gauge mounted directly over the turns and impregnated with the coil. Two such coils were placed in a “common coil” fashion capable of reaching 11T at 4.2K. The measured steady state strain in the coil is compared with results obtained using the FEM code ANSYS. During quenches, the transient strain (due to temperature rise) was also measured and compared with the calculated mechanical time response to a quench.

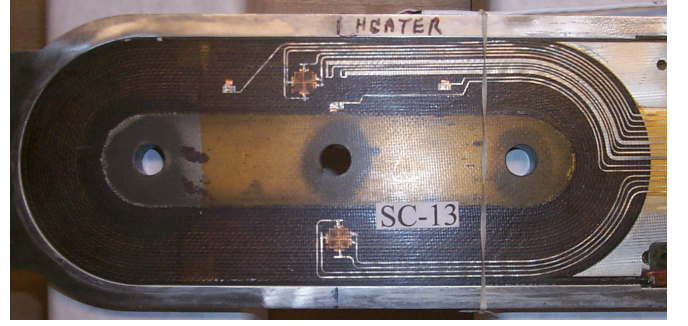
Fig. 4. Coil geometry showing impregnated traces, voltage taps, strain gauge SC13Heater next to the heater and SG13Lead on the opposite side of the island. Only part of the heater is shown above the turns.

A 100μm thick fiberglass cloth was placed between the coil and the trace. Because the gauges are wider than the turns, they measured the averaged strain across 5 turns (8mm). After impregnation, the gauges, trace, turns and island become transparent making them completely visible through (Fig.4).
